**Flood Control Project Maintenance  
Levee Inspections**

## Maintenance Issue Types Only, Levee Inspection Report By Mile - Spring 2020

### Merced Streams Group

Waterway	Bank	Unit Miles	Inspection Start/End	Inspector
Unit No. 01 Black Rascal Diversion	Right	1.61	04/16/2020 04/16/2020	Corey Fujitani

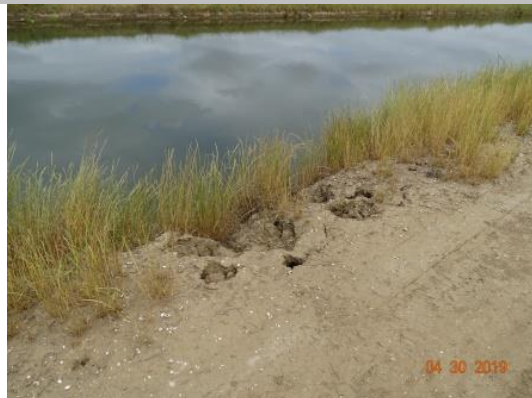
Photo 1 of 1 : SP\_2020\_NA0013\_331\_14\_20200225\_00009.jpg

LM Start	0.75	Rating **	A/W	Issue No.	14
LM End	0.75	Issue Type +	Ma	Location *	LS
Category	Earthen Levee			GPS Latitude/Longitude	
				Start	End
Item	Erosion / Bank Caving			37.325485 °	37.325485 °
				-120.396700 °	-120.396700 °
DWR ID	DWR_NA0013_01_s _ 2019_14				
Comment Code					
E1 : Note and monitor erosion site.					
Inspector Comment

View of erosion on landside slope. (Spring 2019)

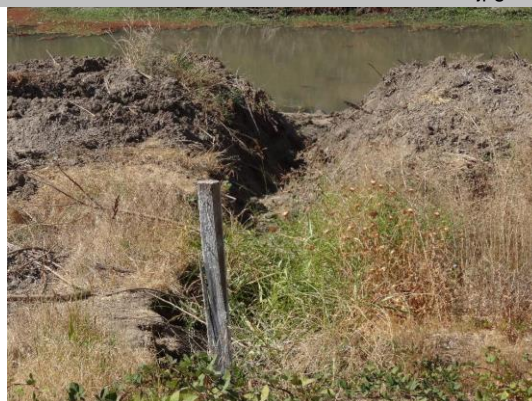
Photo 1 of 3 : UCIP\_SP\_2020\_50156\_35245.jpg

WS view: cobble spillway and channel on waterside.

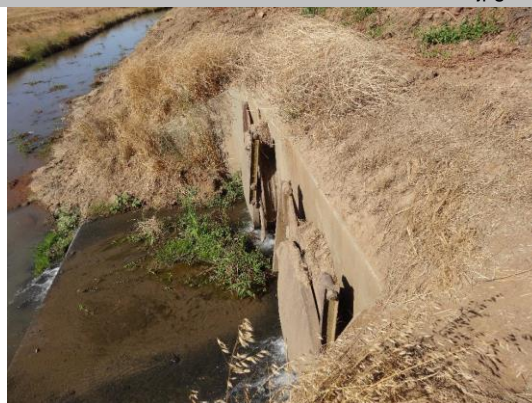
Photo 1 of 3 : UCIP\_SP\_2020\_20965\_35292.jpg

WS view: two 60" CMPs, flap gates, and headwall on channel bank.

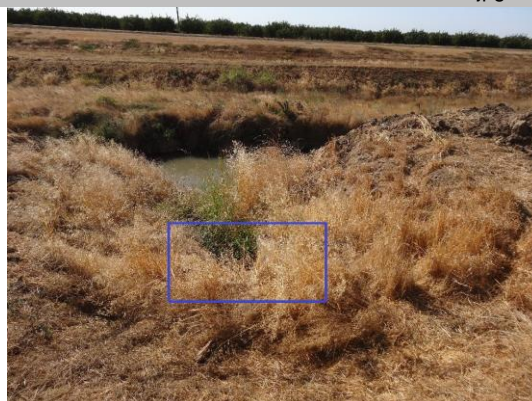
Photo 1 of 3 : UCIP\_SP\_2020\_20984\_35305.jpg

WS view: U type concrete headwall and channel on waterside.

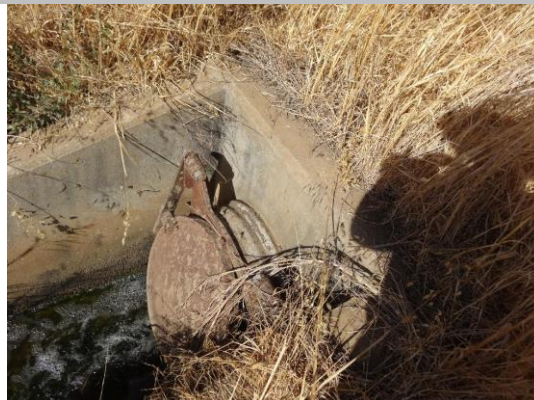
Photo 2 of 3 : UCIP\_SP\_2020\_20984\_35304.jpg

WS view: U typed concrete headwall, CM pipe, and flap gate. It was working during field inspection.

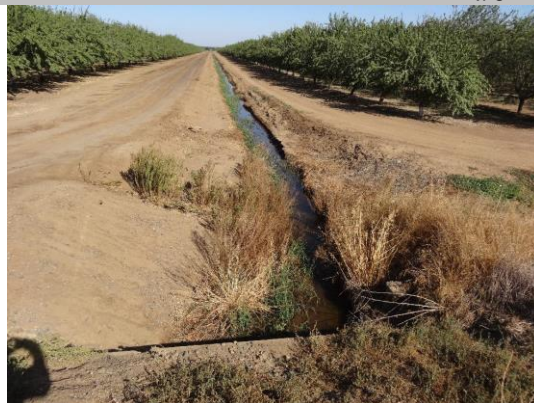
Photo 3 of 3 : UCIP\_SP\_2020\_20984\_35303.jpg

LS view: concrete headwall on levee toe and drainage ditch.

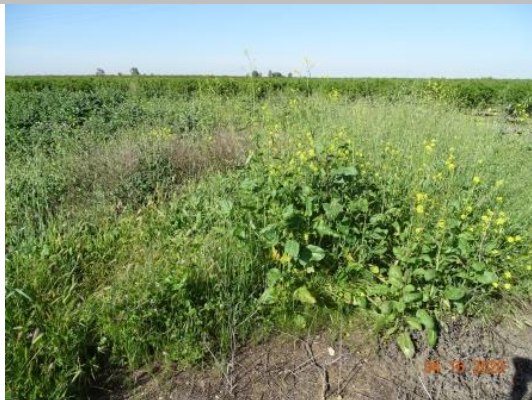
Photo 1 of 1 : SP\_2020\_NA0013\_333\_17\_20200505\_00031.jpg

LM Start	0.00	Rating **	U	Issue No.	17
LM End	0.33	Issue Type +	Ma	Location *	CR
Category	Earthen Levee			GPS Latitude/Longitude	
				Start	End
Item	Vegetation			37.257654 °	37.262387 °
				-120.288501 °	-120.288304 °
DWR ID	DWR_NA0013_03_s_2020_17				
Comment Code					
V1 : Control annual grass and weeds on the levee slopes and easements.					
Inspector Comment

Keep the levee crown free of vegetation. (Spring 2020)

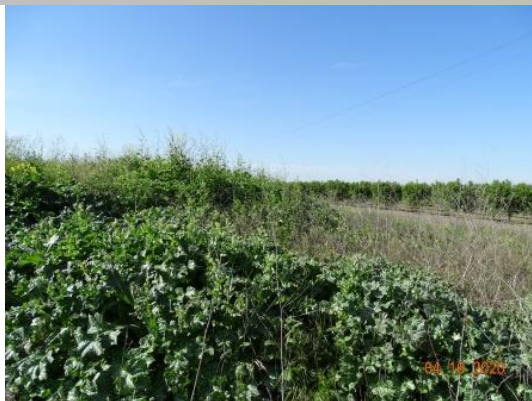
Photo 1 of 1 : SP\_2020\_NA0013\_333\_14\_20200505\_00033.jpg

LM Start	0.00	Rating **	U	Issue No.	14
LM End	0.33	Issue Type +	Ma	Location *	LS
Category	Earthen Levee			GPS Latitude/Longitude	
				Start	End
Item	Vegetation			37.257654 °	37.262390 °
				-120.288501 °	-120.288307 °
DWR ID	DWR_NA0013_03_s_2020_14				
Comment Code					
V1 : Control annual grass and weeds on the levee slopes and easements.					
Inspector Comment					
to the start

Looking downstream along the landside slope. (Spring 2020)

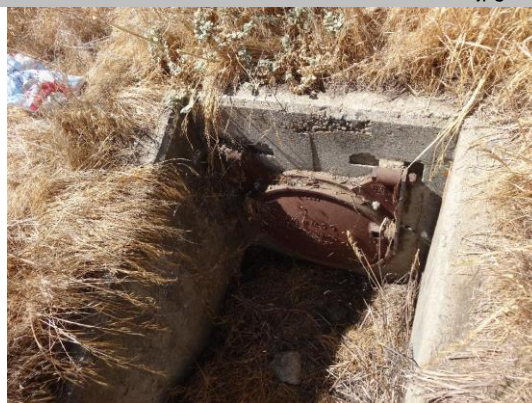
Photo 1 of 3 : UCIP\_SP\_2020\_41815\_35533.jpg

Comment Code						
Inspector Comment						
DS_ID:23060						
FS_ID:41815						
EP_NO: N/A						
Repair Type: Non-Urgent						
Crossing Status: Found						
UCIP Comments: 09/17/2013 - more than a half of inet pipe burried on						
LS. - needs vegetation cleaning on both sides.- inlet needs silt						
removed and cleaning. (DWR UCIP - P. Amaty)						
FIELD_STRUCT_DESC: 24-inch corrugated metal gravity drainage						
pipe through the levee, 6 feet below the crown. Concrete headwall, flap						
gate, and concrete grouted cobble spillway on the waterside (WS) toe.						
Concrete headwall on the landside (LS) toe. [Additional Reference(s):						
DWR Levee Log, 2005. USACE San Joaquin O&M Manual 607, June						
1962, (HLM 0.18)].						
FS Date: 9/17/2013

WS view: U typed concrete headwall, CM pipe, and flap gate.

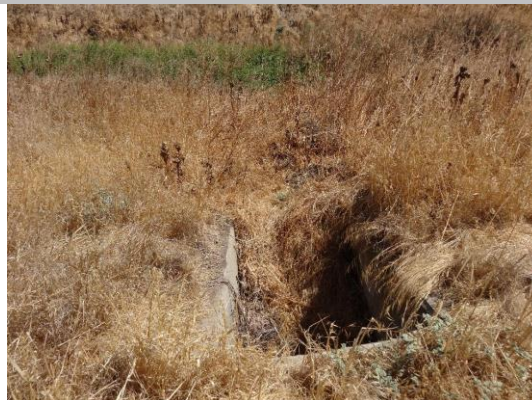
Photo 2 of 3 : UCIP\_SP\_2020\_41815\_35532.jpg

WS view: Silt needs to be removed. Vegetations needs to be cleared.

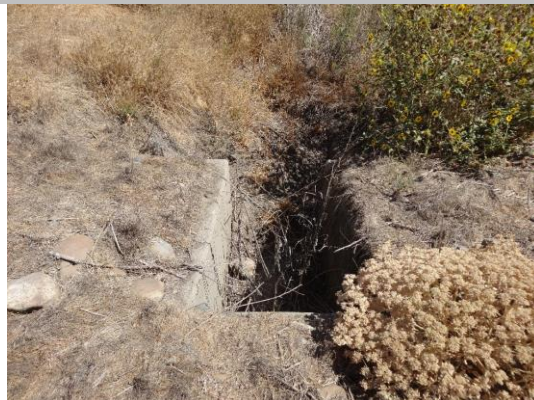
Photo 1 of 3 : UCIP\_SP\_2020\_50144\_35422.jpg

WS view: U typed concrete headwall, cobble spillway, and channel on waterside.

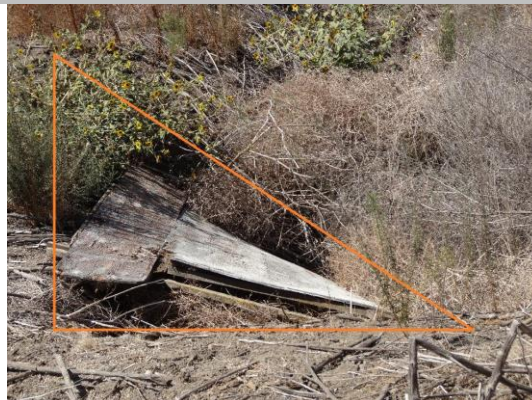
Photo 3 of 3 : UCIP\_SP\_2020\_50144\_35420.jpg

LS view: Debris dumped on inlet structure. Needs to be cleared or abandoned properly.

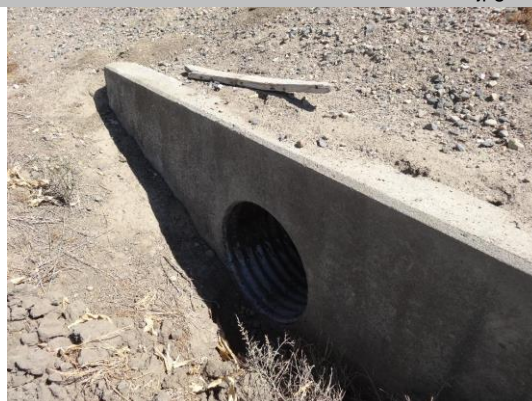
Photo 3 of 3 : UCIP\_SP\_2020\_50151\_35541.jpg

LS view: concrete headwall and CM pipe.

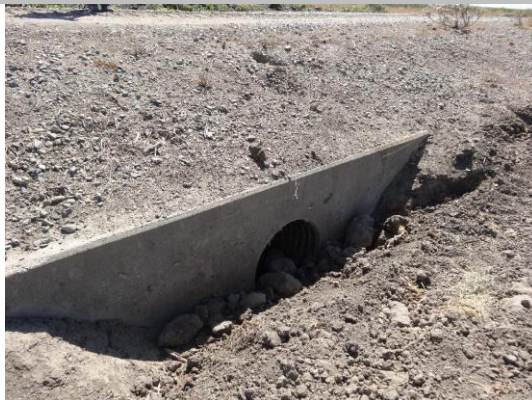
Photo 2 of 3 : UCIP\_SP\_2020\_21063\_35501.jpg

LS view: concrete headwall and CM pipe. Inlet needs clearing.

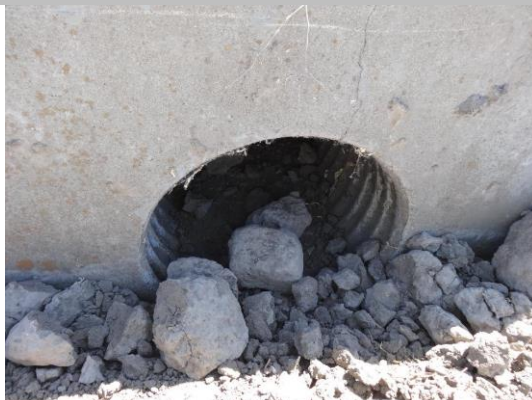
Photo 3 of 3 : UCIP\_SP\_2020\_21063\_35500.jpg

LS view: closer view of CM pipe. Inlet needs cleaning &amp; clearing.

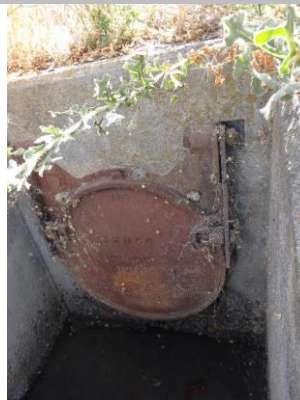
Photo 2 of 3 : UCIP\_SP\_2020\_50148\_35612.jpg

WS view: U typed concrete headwall, CM pipe, and flap gate.

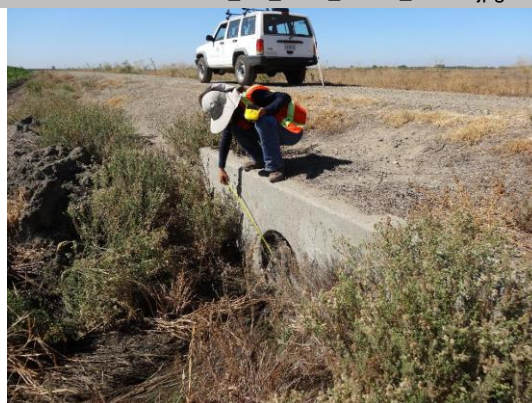
Photo 3 of 3 : UCIP\_SP\_2020\_50148\_35611.jpg

LS view: concrete headwall and CM pipe.

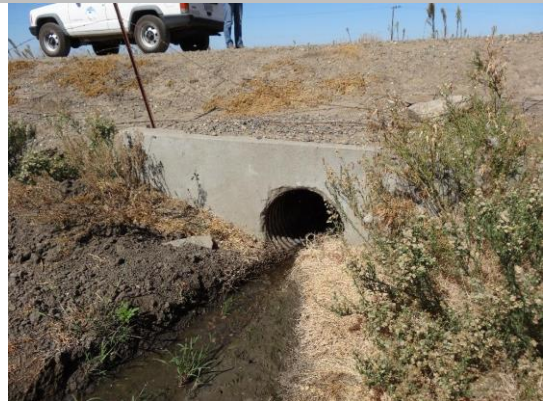
Photo 3 of 3 : UCIP\_SP\_2020\_21126\_35654.jpg

LS view: concrete headwall and CM pipe. Drain pipe was working during field survey.

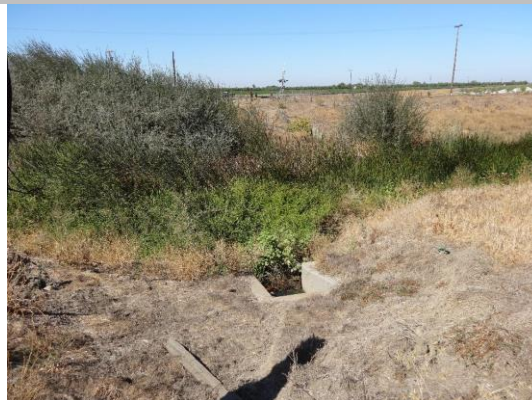
Photo 1 of 3 : UCIP\_SP\_2020\_21127\_35657.jpg

WS view: U typed concrete headwall and channel on waterside.

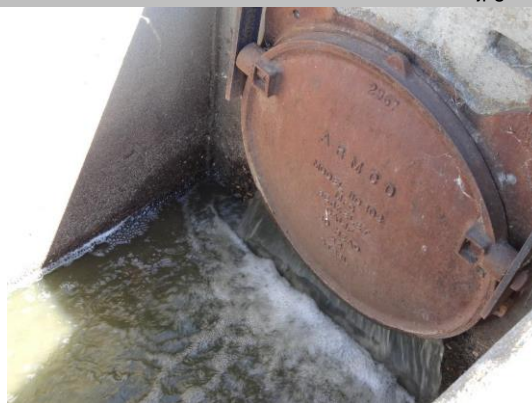
Photo 3 of 3 : UCIP\_SP\_2020\_21127\_35655.jpg

WS view: U typed concrete headwall, CM pipe, and flap gate. Drainage was working during survey.

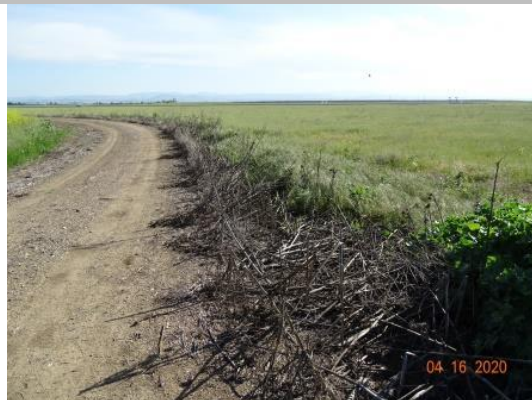
Photo 1 of 1 : SP\_2020\_NA0013\_334\_13\_20200505\_00034.jpg

LM Start	1.08	Rating **	U	Issue No.	13
LM End	1.41	Issue Type +	Ma	Location *	LS
Category	Earthen Levee			GPS Latitude/Longitude	
				Start	End
Item	Vegetation			37.262167 °	37.257437 °
				-120.288150 °	-120.288184 °
DWR ID	DWR_NA0013_04_s_2020_13				
Comment Code					
V1 : Control annual grass and weeds on the levee slopes and easements.					
Inspector Comment

View of vegetation growing along the landside slope. (Spring 2020)
